EPA/OEPA SITE VISITS
OHIO VALLEY COAL (TOVCC)
and
AMERICAN ENERGY (AEC)

October 25, 26 and 27 2011

December 16, 2011

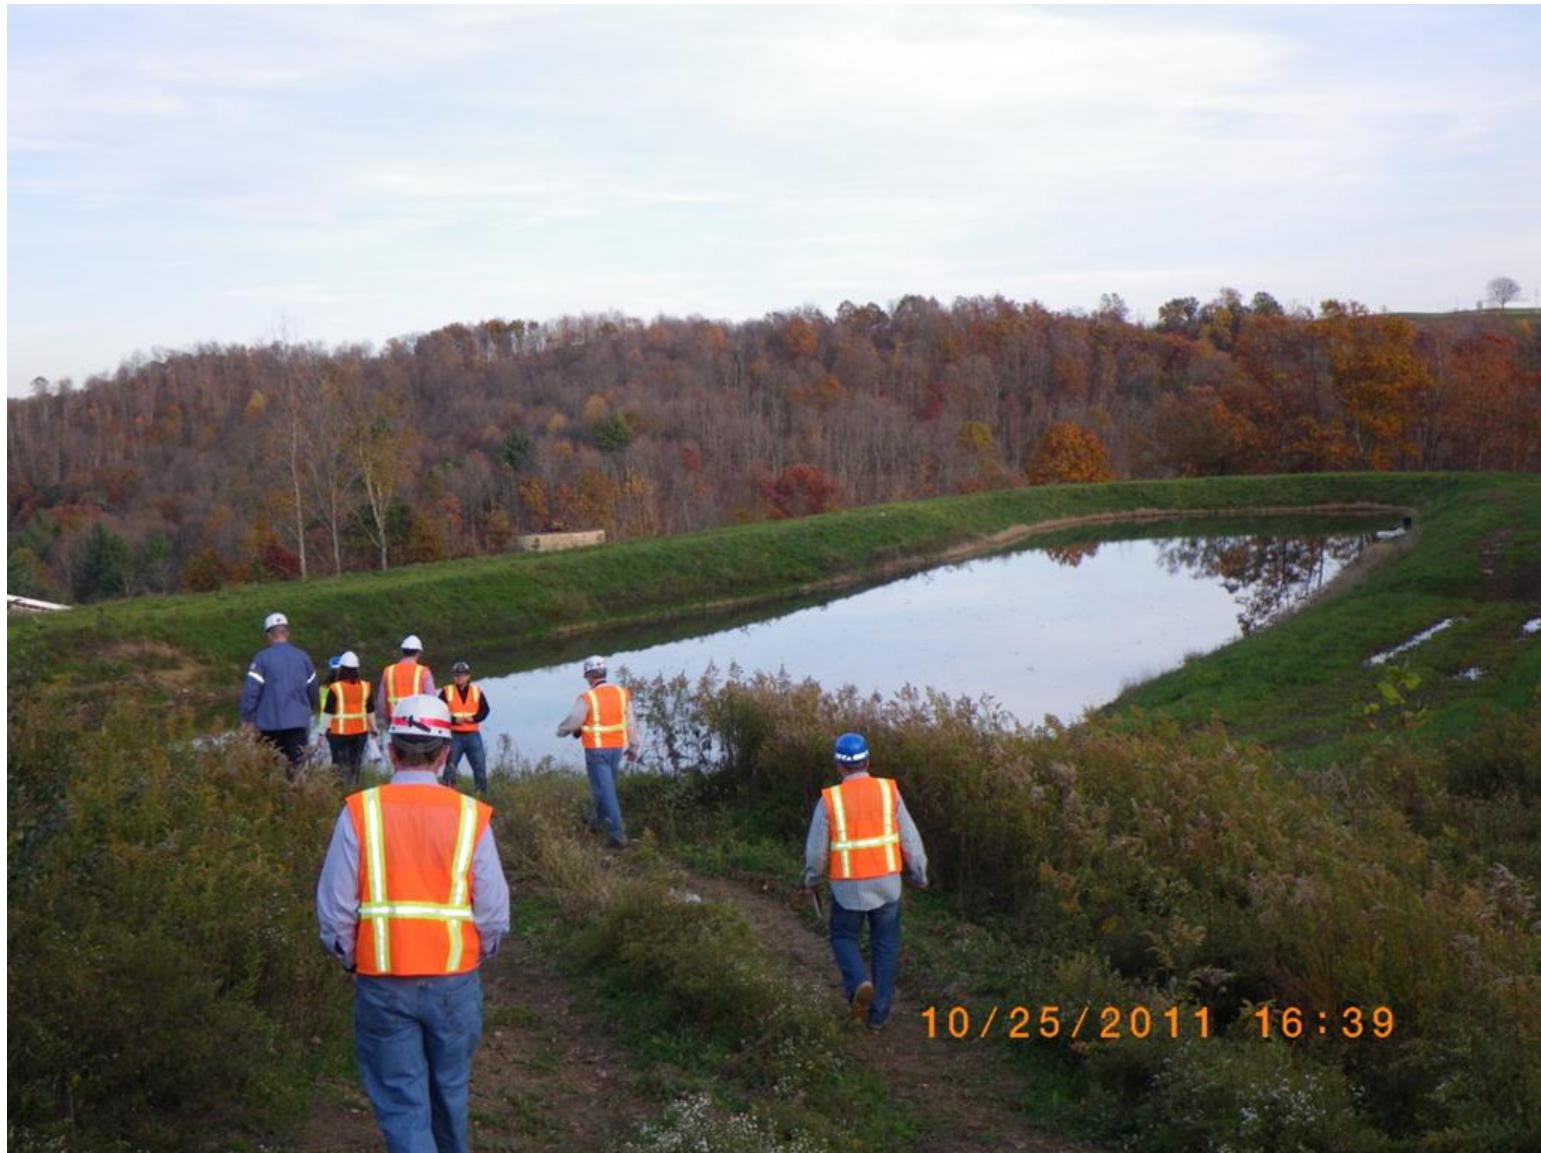
Pond 13 AEC – expected to see all
ponds to look like this

AEC Pond 13 – discharges to unnamed tributary of Piney Creek.

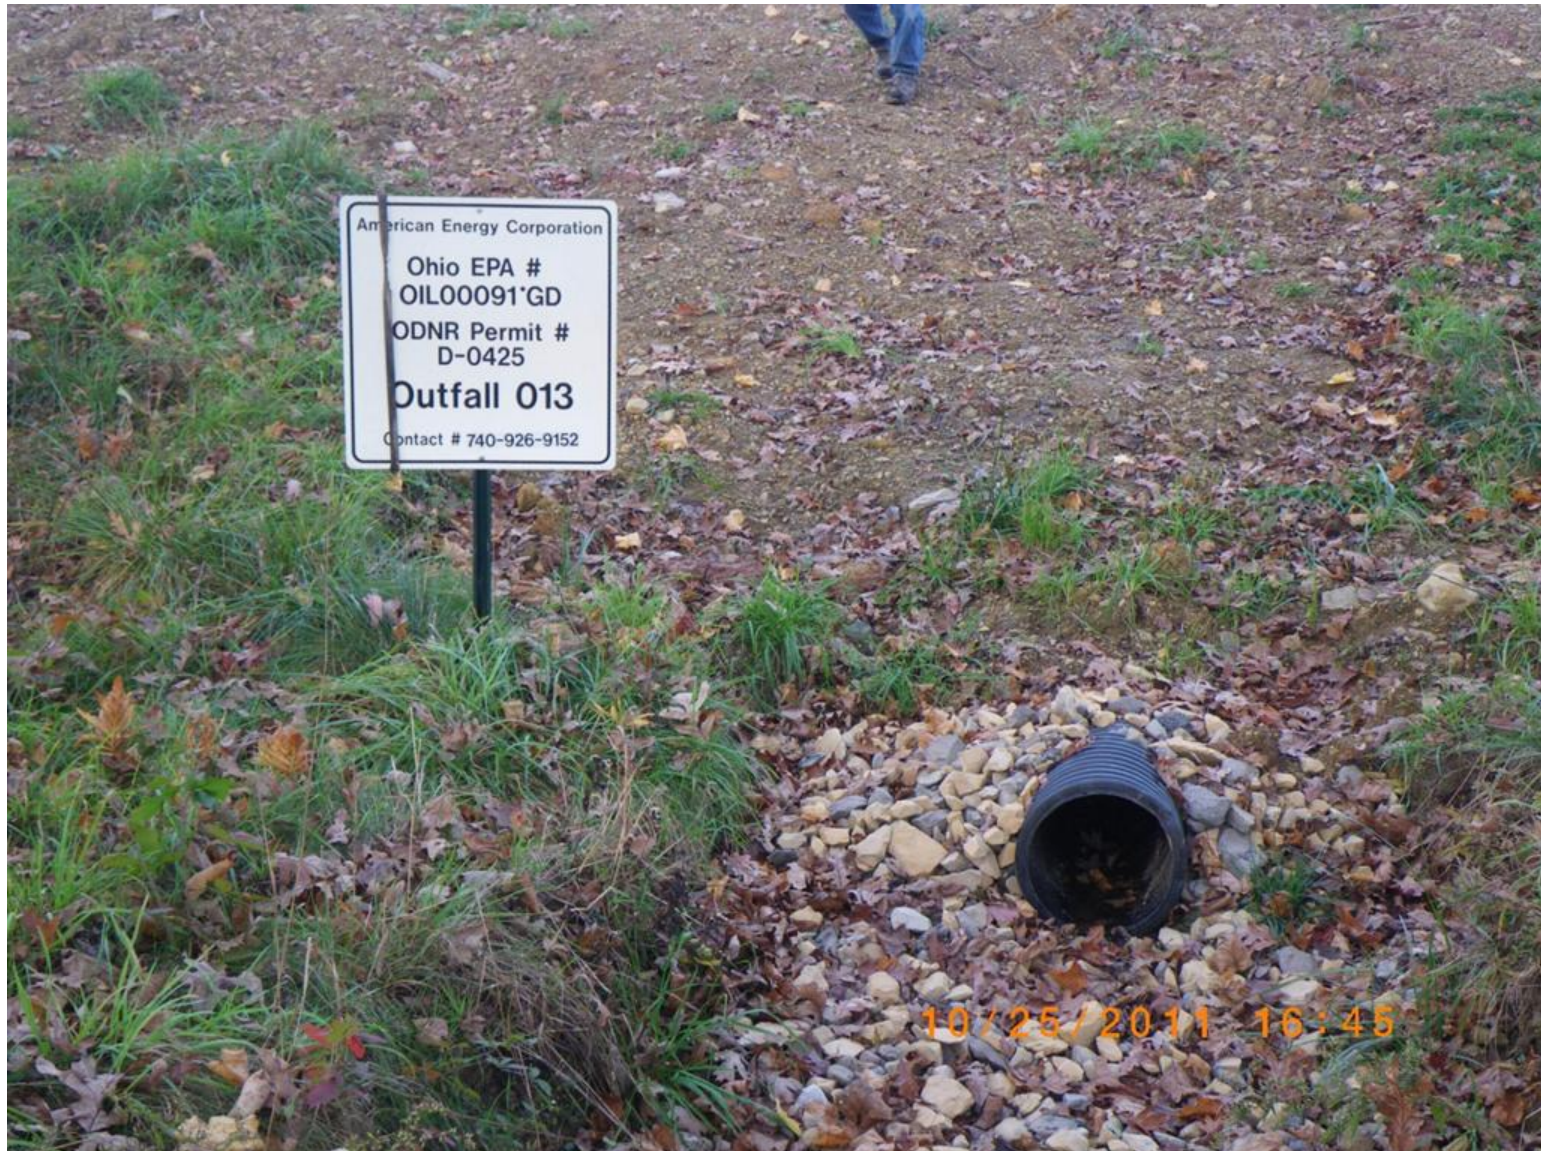
AEC Pond 13 outfall – discharges to unnamed tributary to Piney Creek – slope from pipe should allow for representative flow sampling

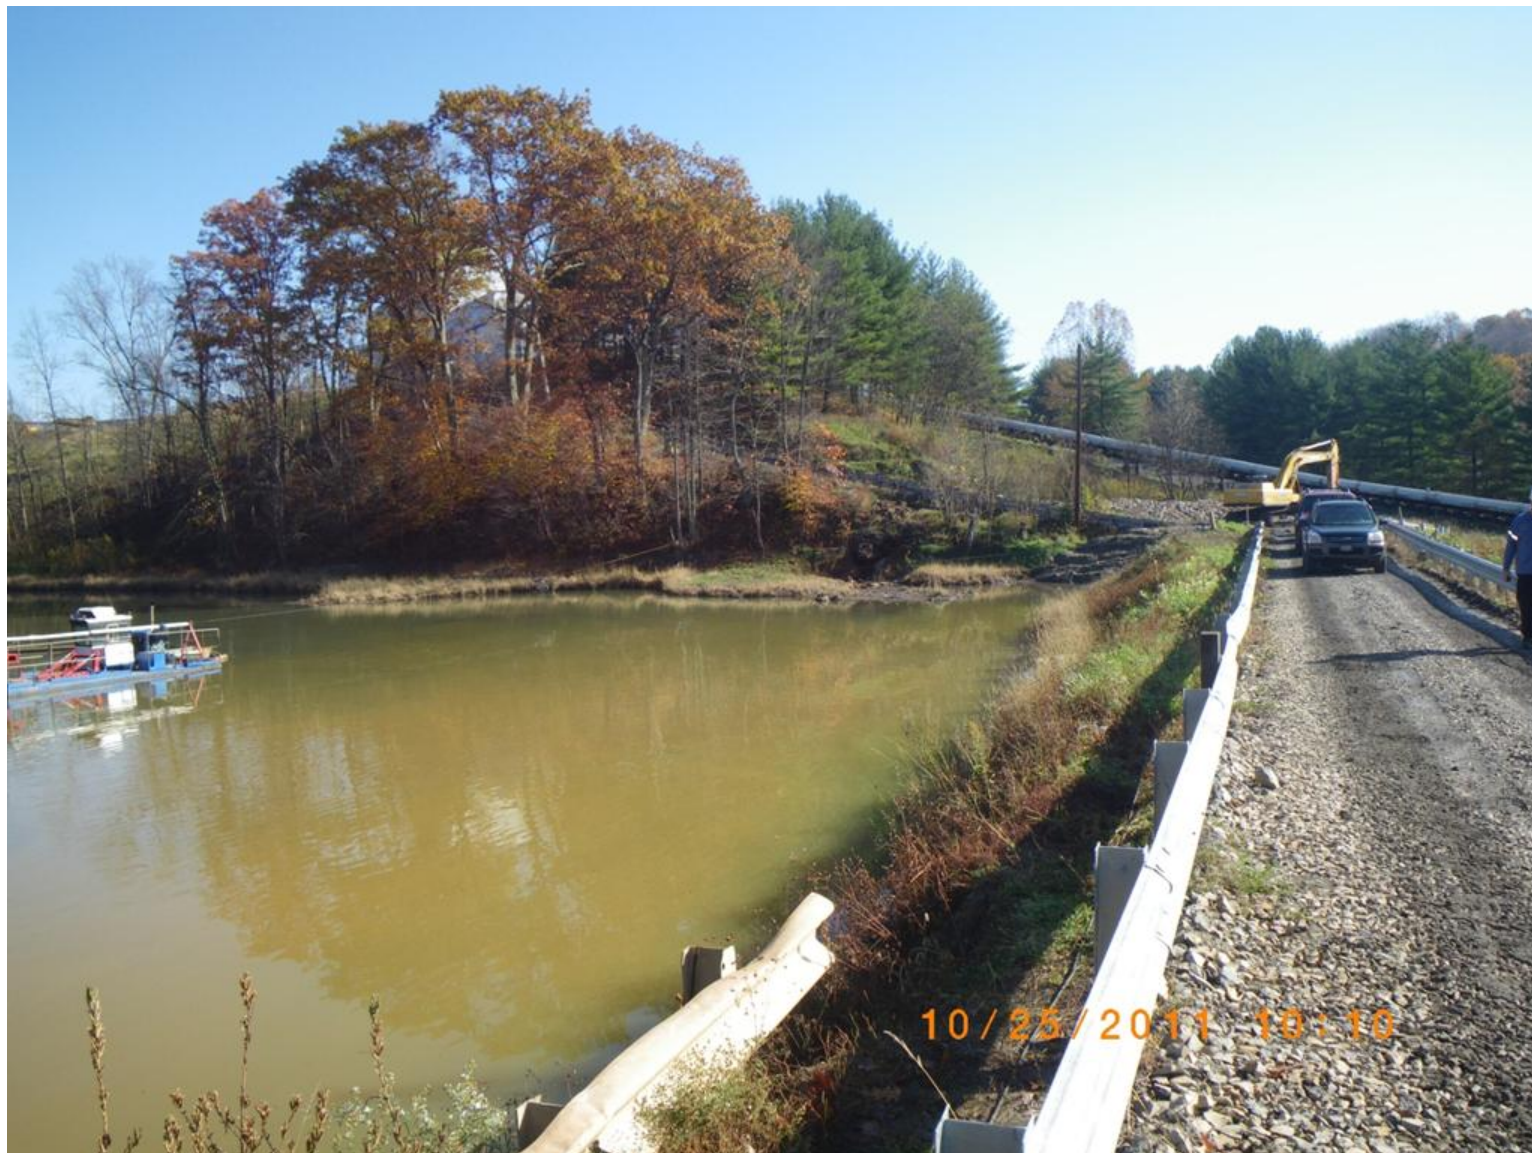
Pond 10 Ohio Valley Coal

Pond 10 pumped to Impoundment 2 –
does not receive chemical treatment,
OEPA may permit discharge from this
location in next permit.

TOVCC Pond 10. Emergency overflow located bottom right corner of photo. Photo represents lack of adequate freeboard.

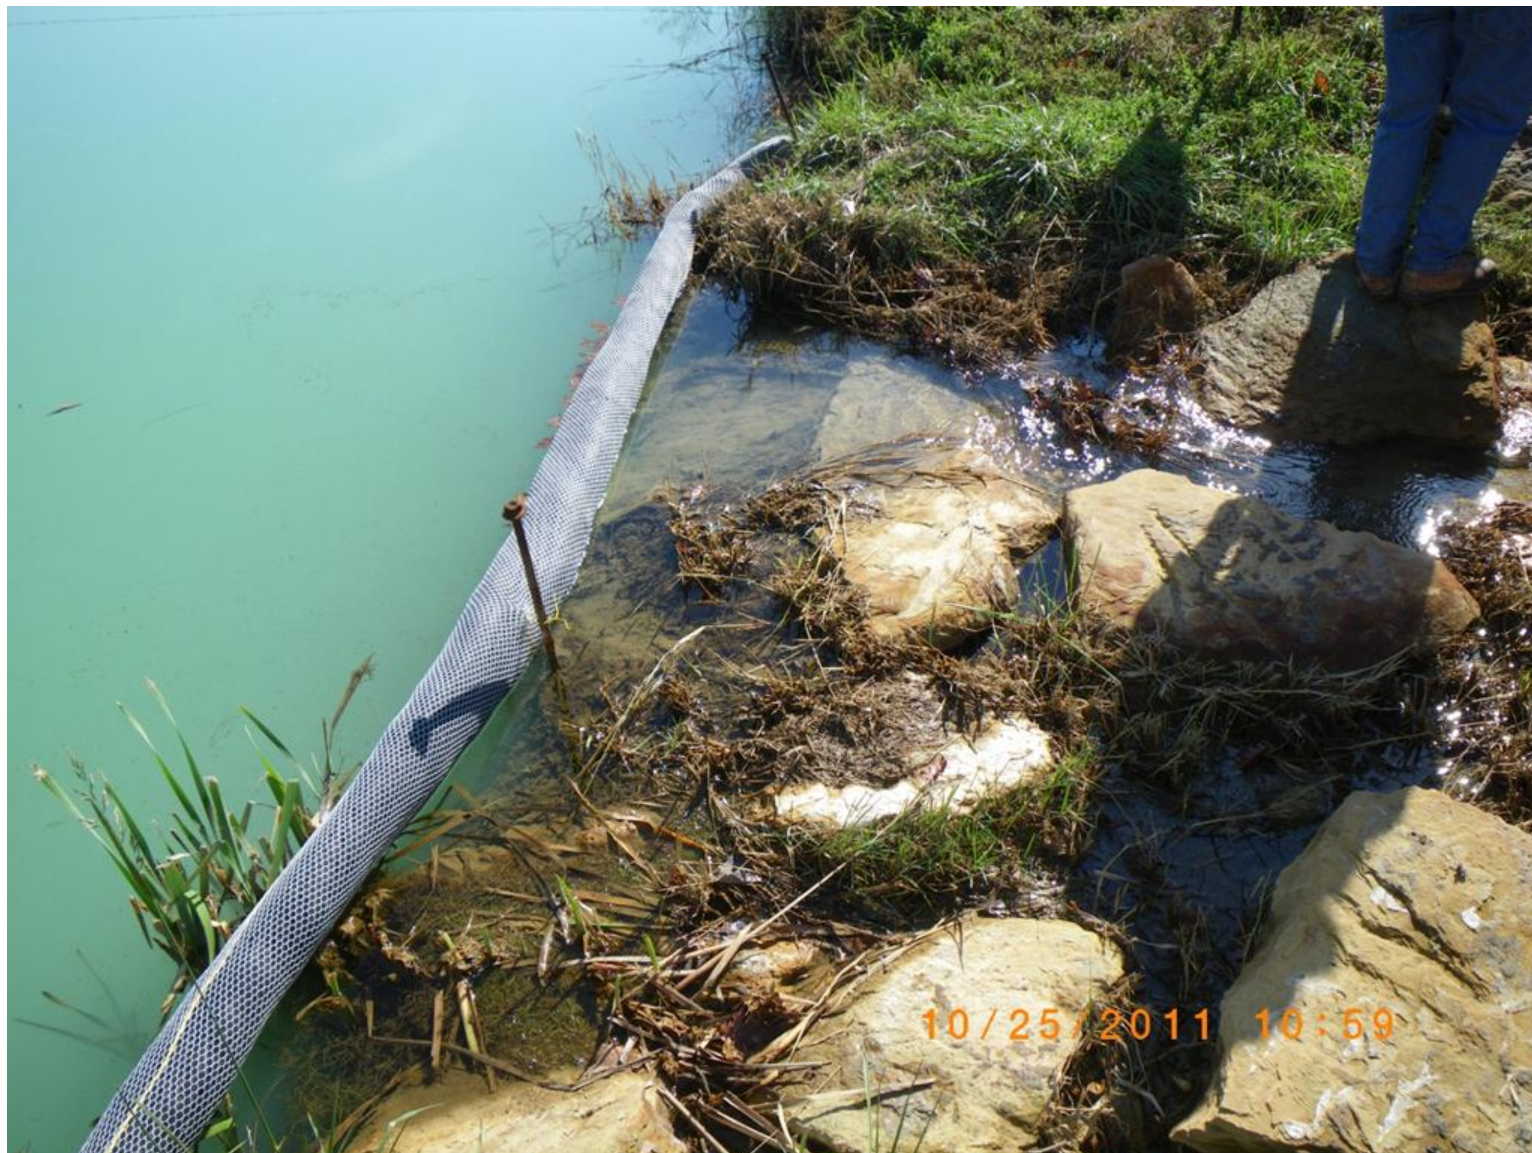
Ohio Valley Coal Pond 13

Receives treatment – discharges to
Perkin's Run

TOVCC Pond 13 outlet/discharge location close-up. Illustrates concern of achieving adequate flow monitoring/water quality samples

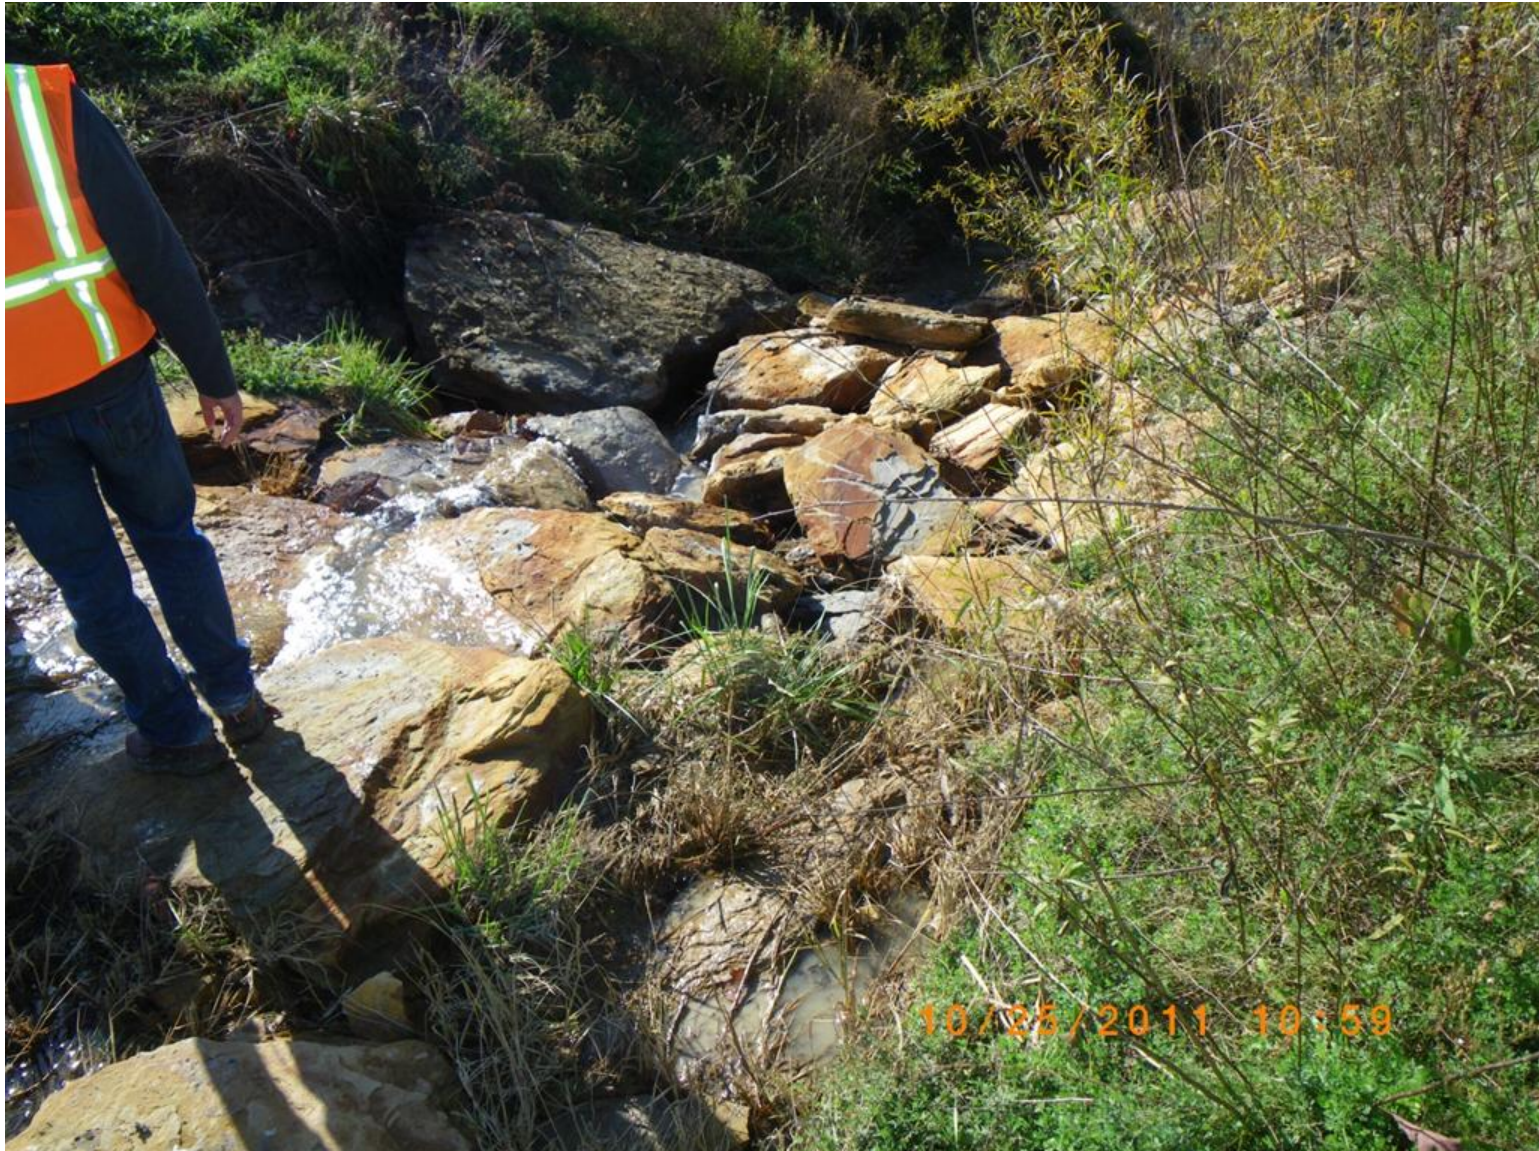
Downstream from outlet of TOVCC Pond 13. . Illustrates the difficulty of achieving adequate flow monitoring/water quality samples

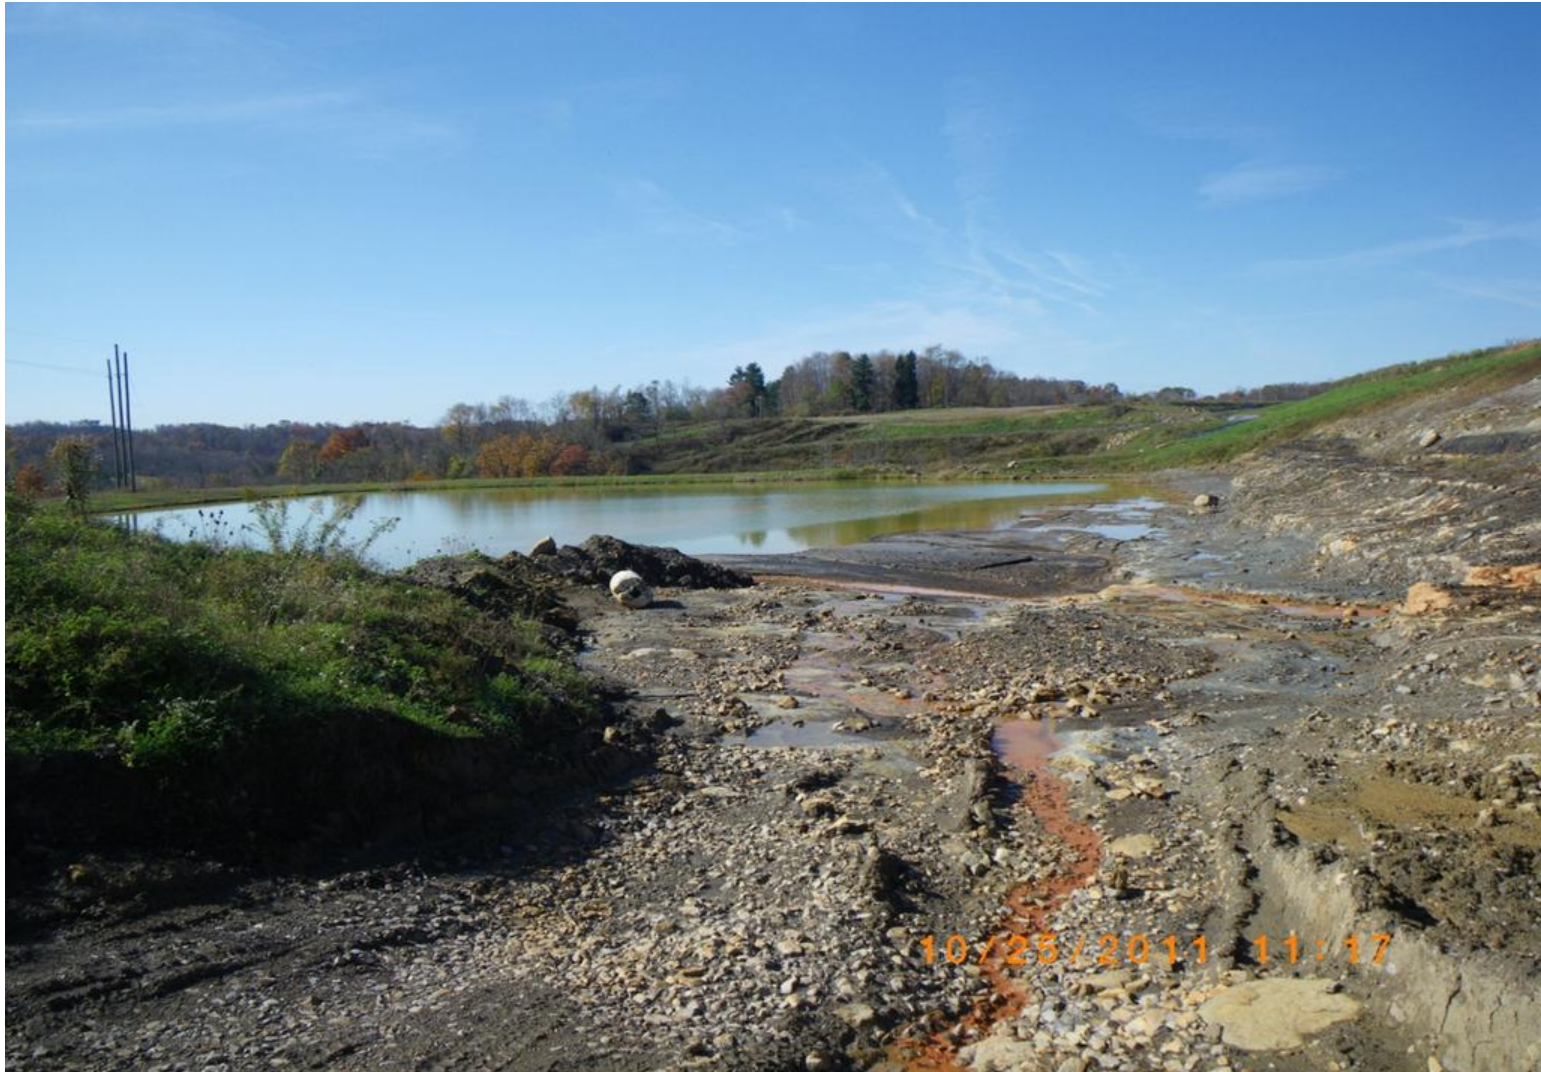
Pond 14 Ohio Valley Coal

TOVCC Pond 14. Inflow into pond. Spillway was the outfall on the far end of the pond – flow conveyed to TOVCC Pond 13. Picture depicts lack of freeboard. Also note slide suggests pond could potentially discharge along dirt roadway area at forefront of photo.

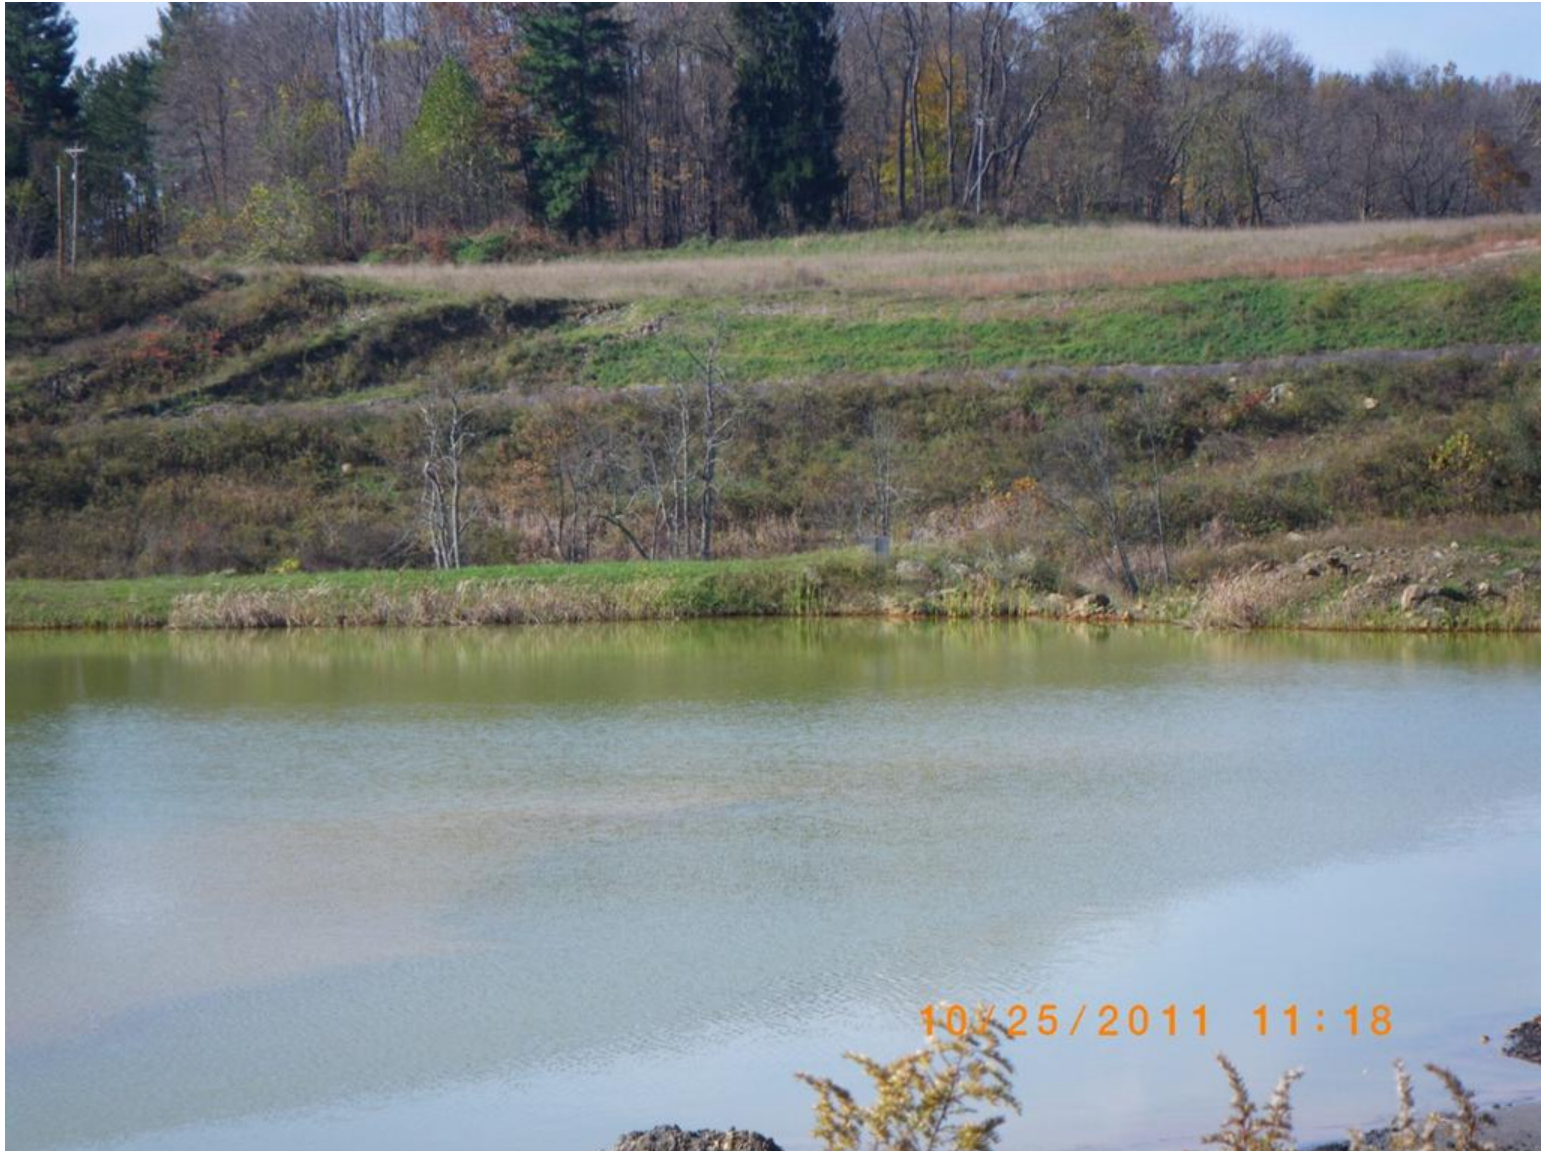
TOVCC Pond 14 – note freeboard

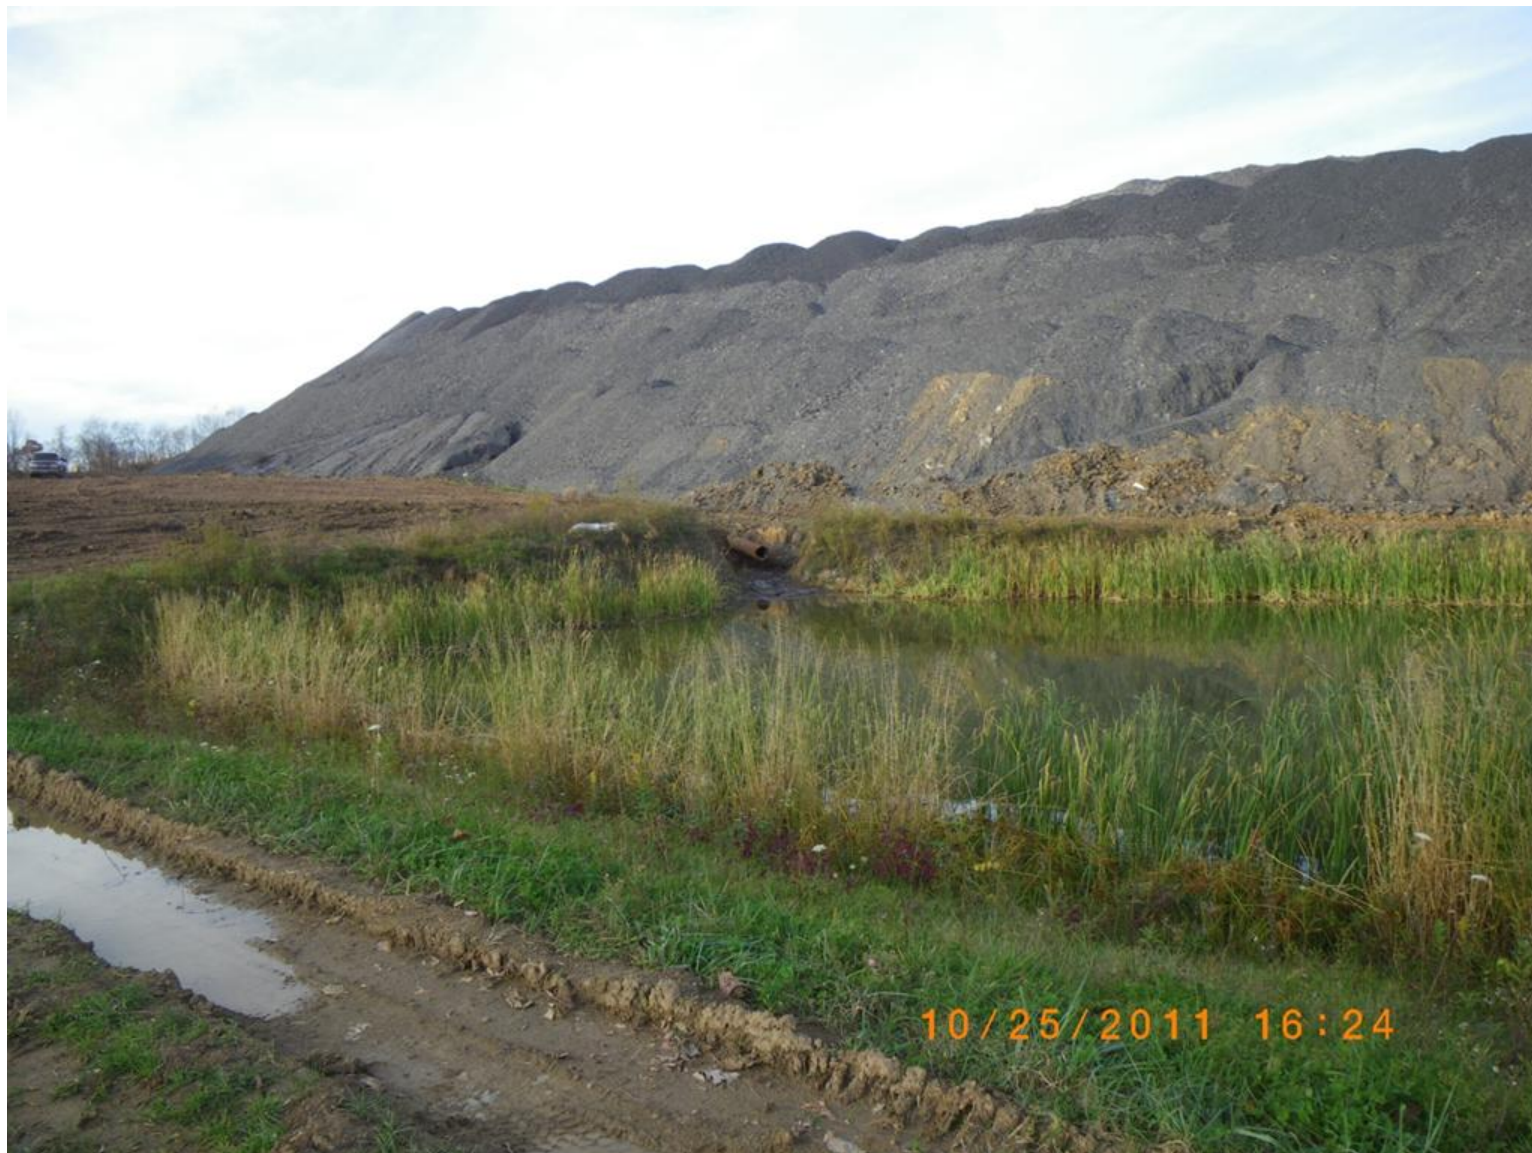
Pond 14 American Energy

Pond 14 AEC – inlet – pond receives run-off from refuse pile

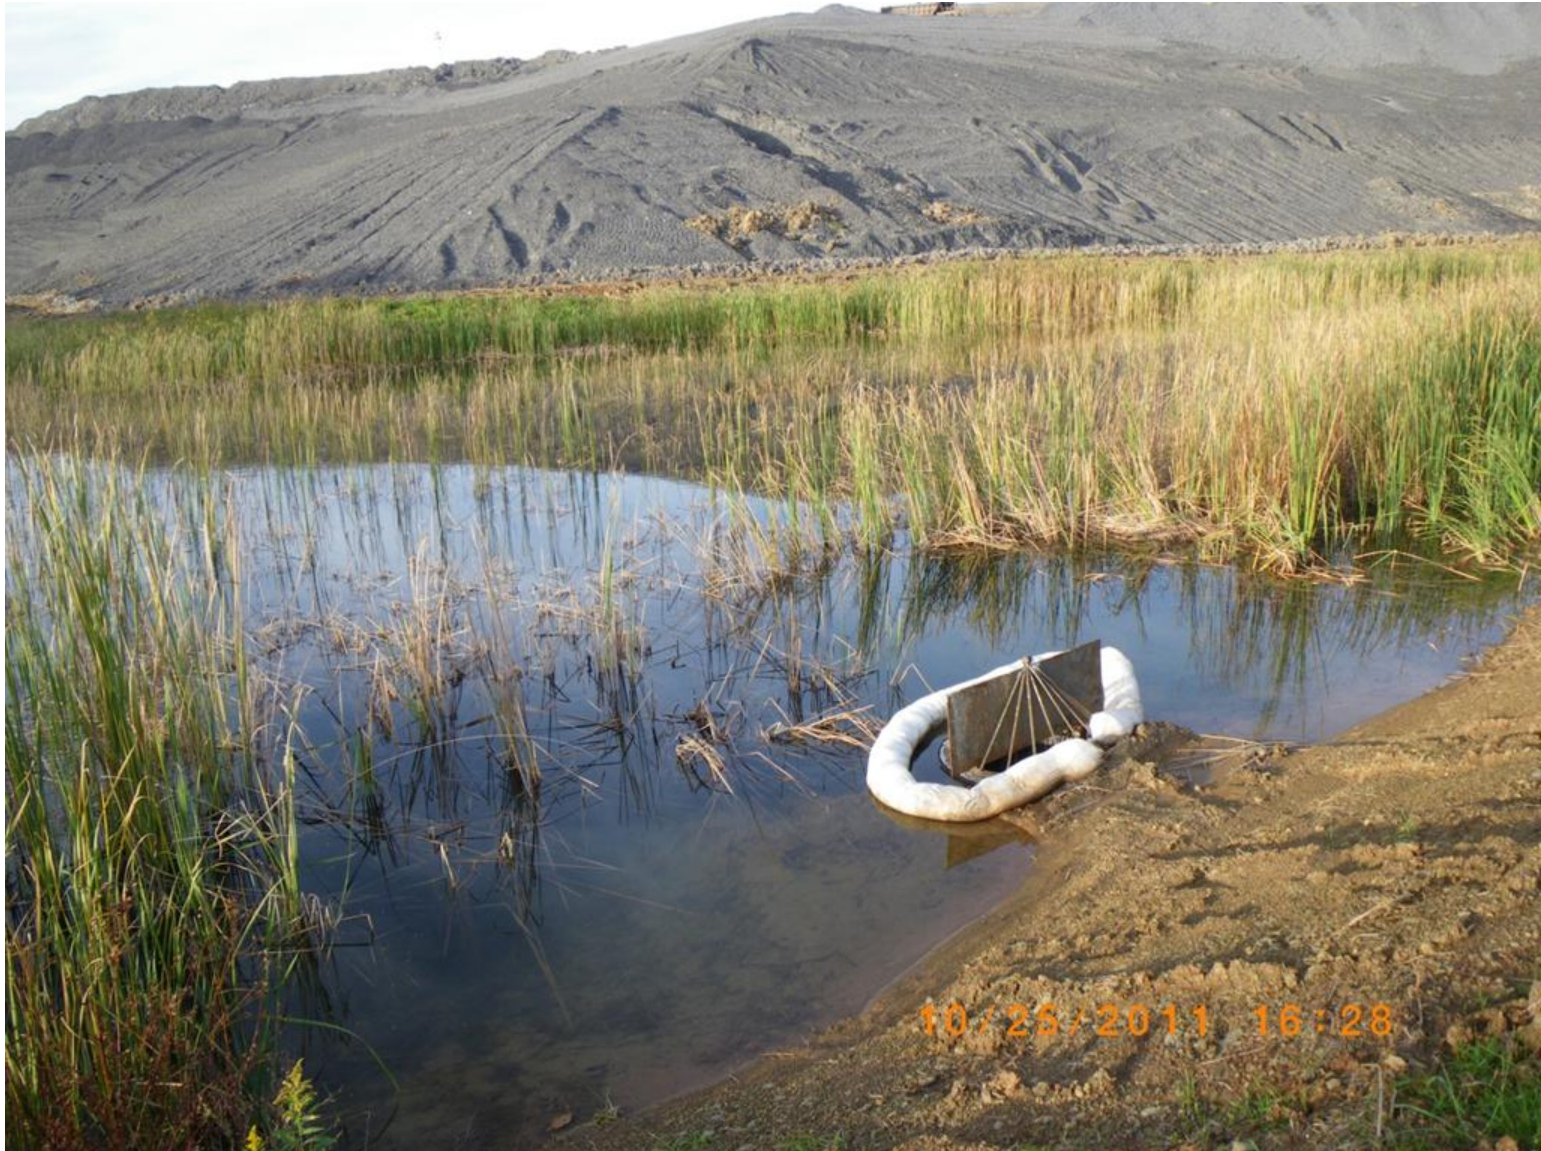
AEC Pond 14 – outlet from pond 14 - note sediment level in pond

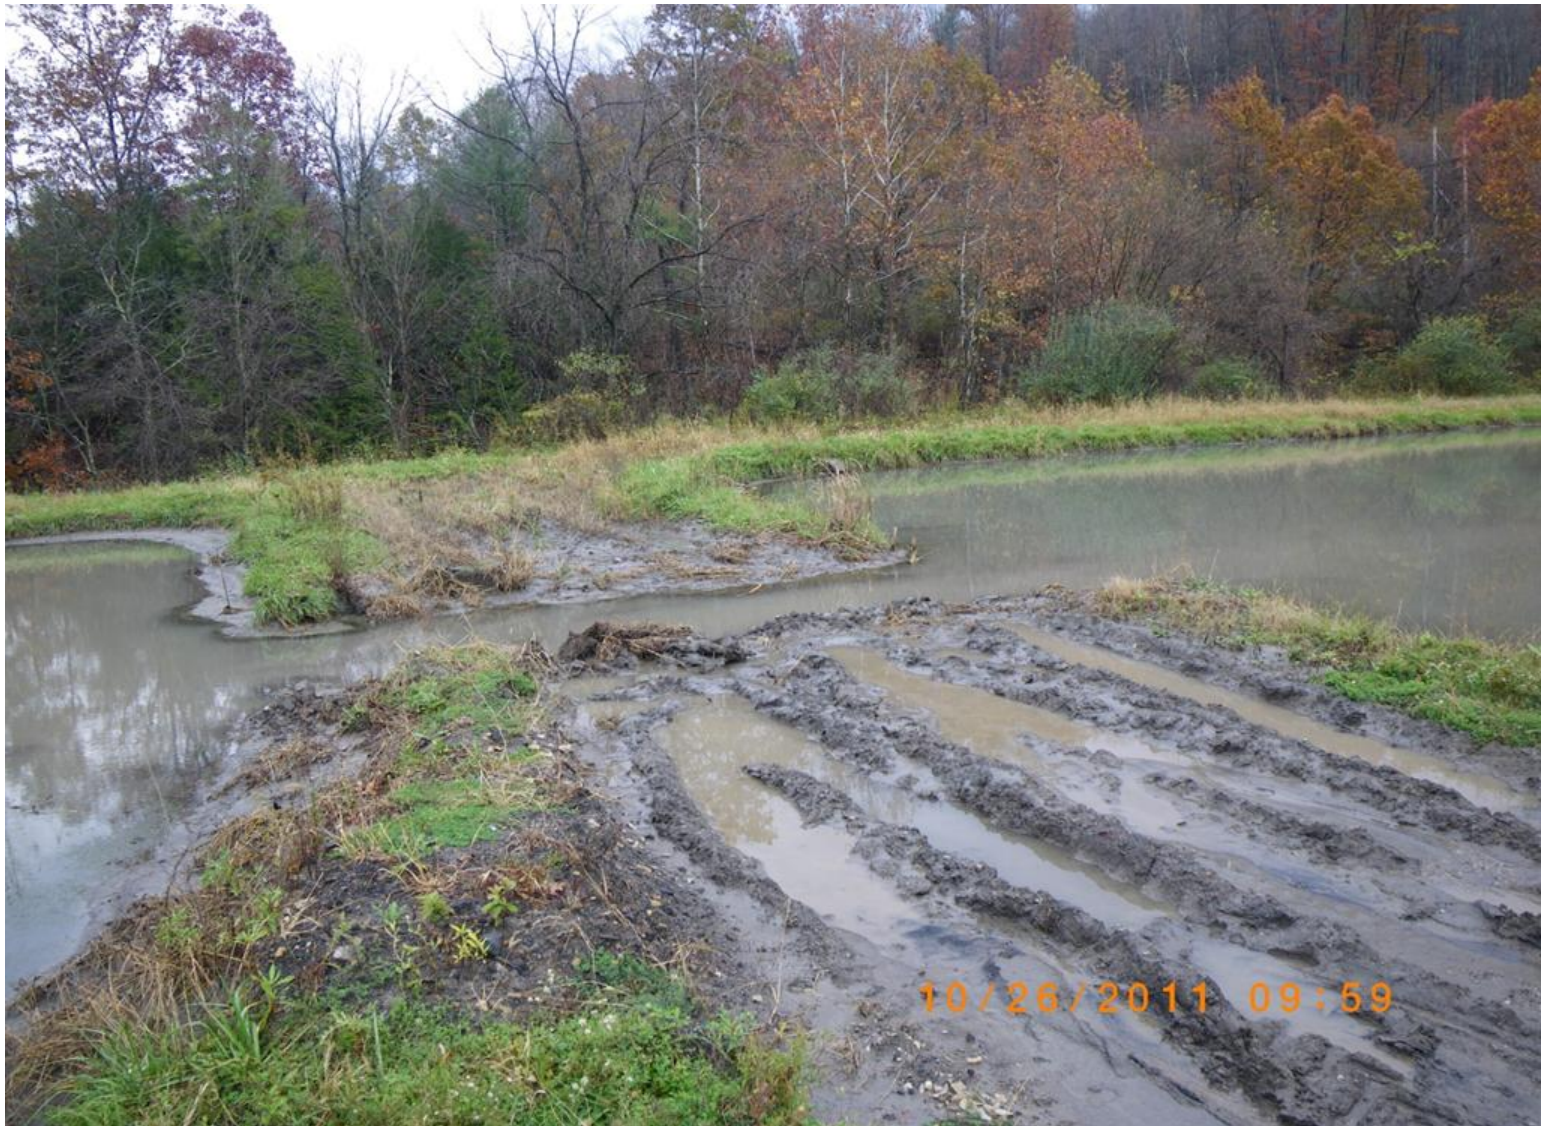
8 series ponds AEC

Outfall Pond 8a to Pond 8b – as-built drawing showed rip-rap, spillway, pipe. Also picture depicts lack of adequate freeboard. Concern is that current O&M prevents these ponds from acting in series as sediment control basins.

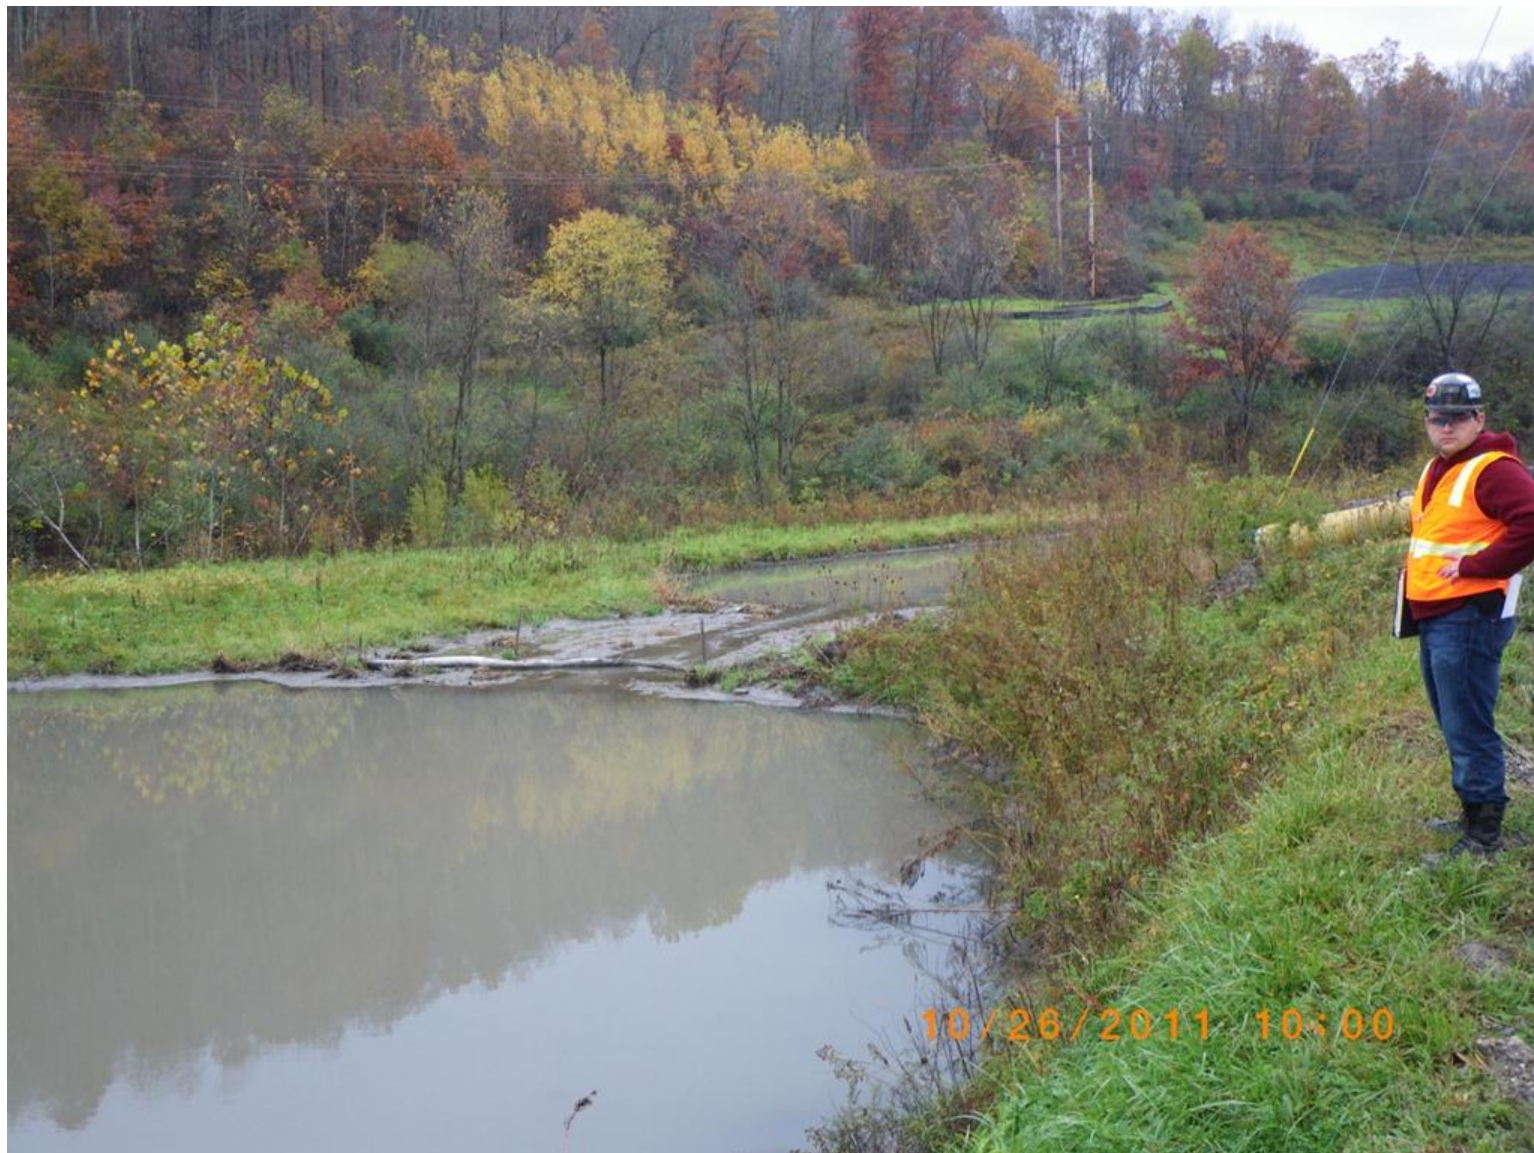
AEC Pond 8b to Pond 8c – same concerns as previous photo.

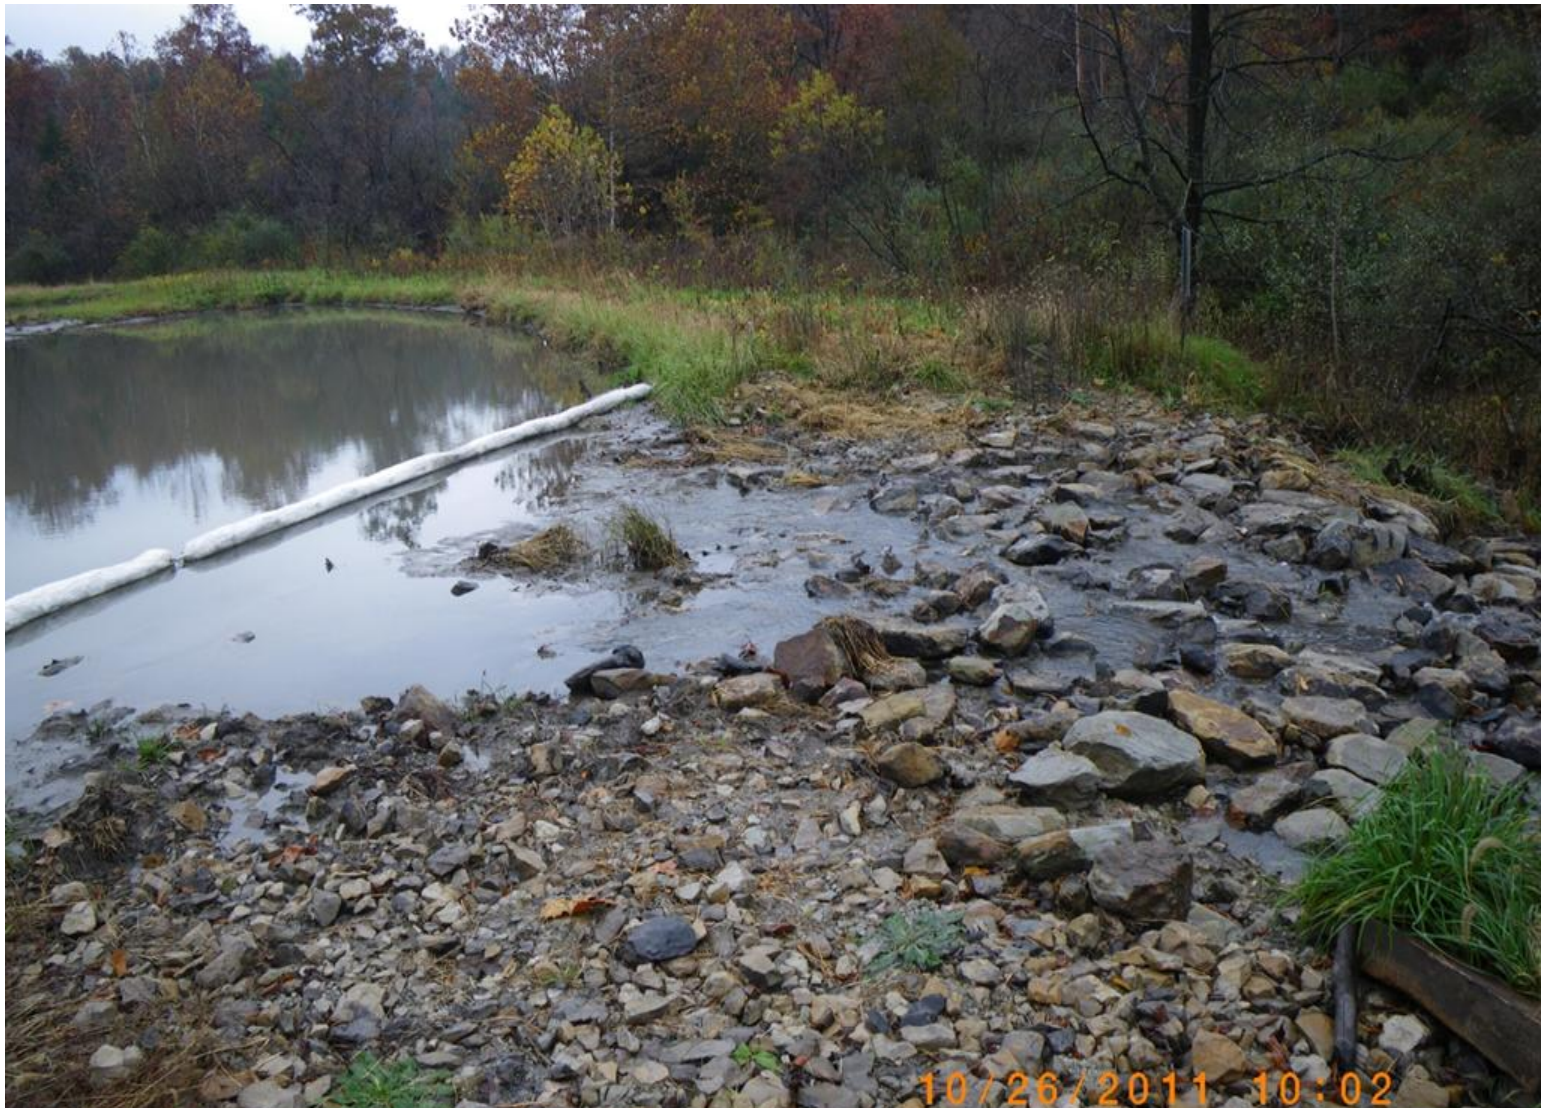
Outfall 8c discharge location for AEC 8 series ponds – undefined discharge location – concerned about ability to collect accurate/representative flow/water quality measurements.

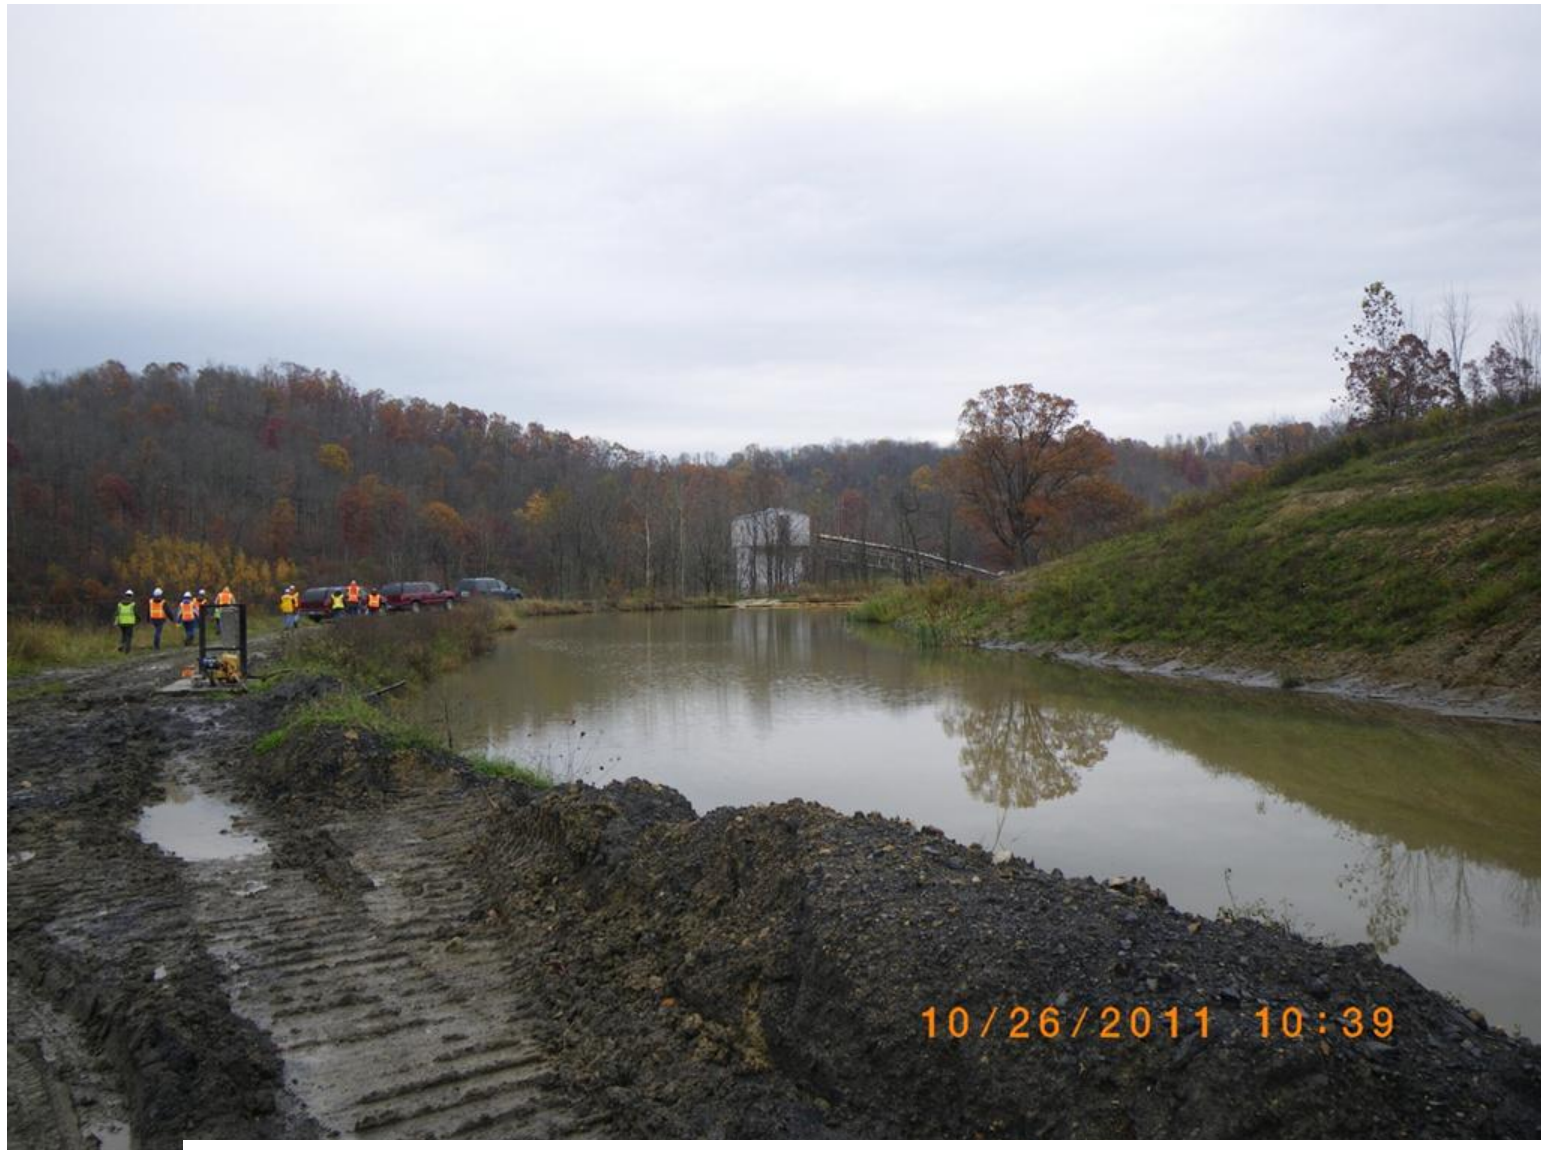
Pond 12 AEC

AEC Pond 12 – lack of vegetation, incised berm – better erosion control measures would aid in pond performance.
